15. Supplementary Notes			
16. Abstract  About 11:06 p.m. on June 5, 1975, a Reading Company commuter train struck a tractor-semitrailer (truck) at a grade crossing near Yardley, Pennsylvania. The truck was transporting three coils of steel, two of which penetrated the first commuter car. The three occupants of the lead car were killed and an occupant of the second car was injured slightly. The truckdriver was uninjured. The semitrailer was torn from the tractor and damaged beyond repair and the lead commuter car was damaged extensively.  At the time of the collision, the automatic grade crossing signal system was functioning. The truckdriver said he had not seen or heard the warning signals.  The National Transportation Safety Board determines that the probable cause of the accident was the failure of the truckdriver to stop the truck in accordance with the warning signals.

About 11:06 p.m. on June 5, 1975, a Reading Company commuter train struck a tractor-semitrailer (truck) at a grade crossing near Yardley, Pennsylvania. The truck was transporting three coils of steel, two of which penetrated the first commuter car. The three occupants of the lead car were killed and an occupan

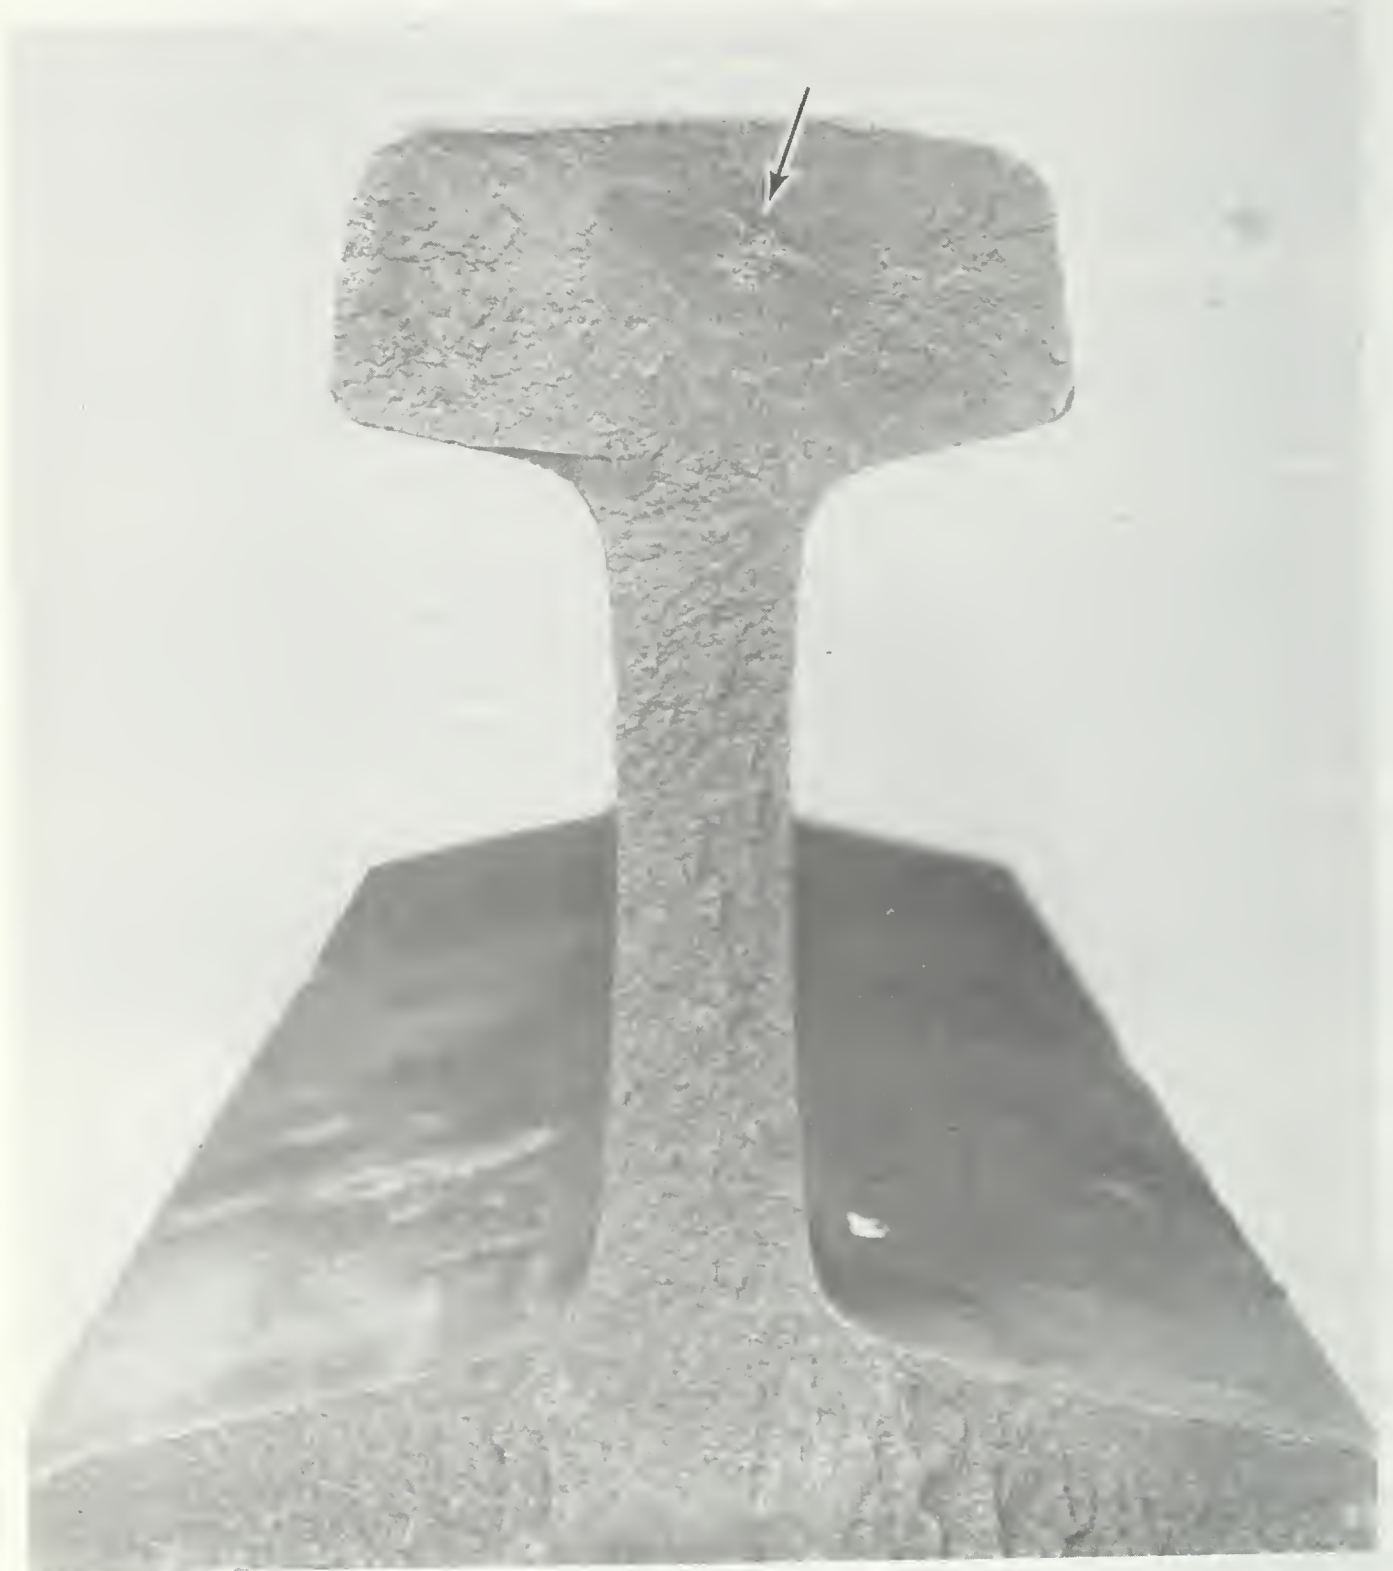
Figure 4. Cross-section of rail section showing nucleus of initial failure.

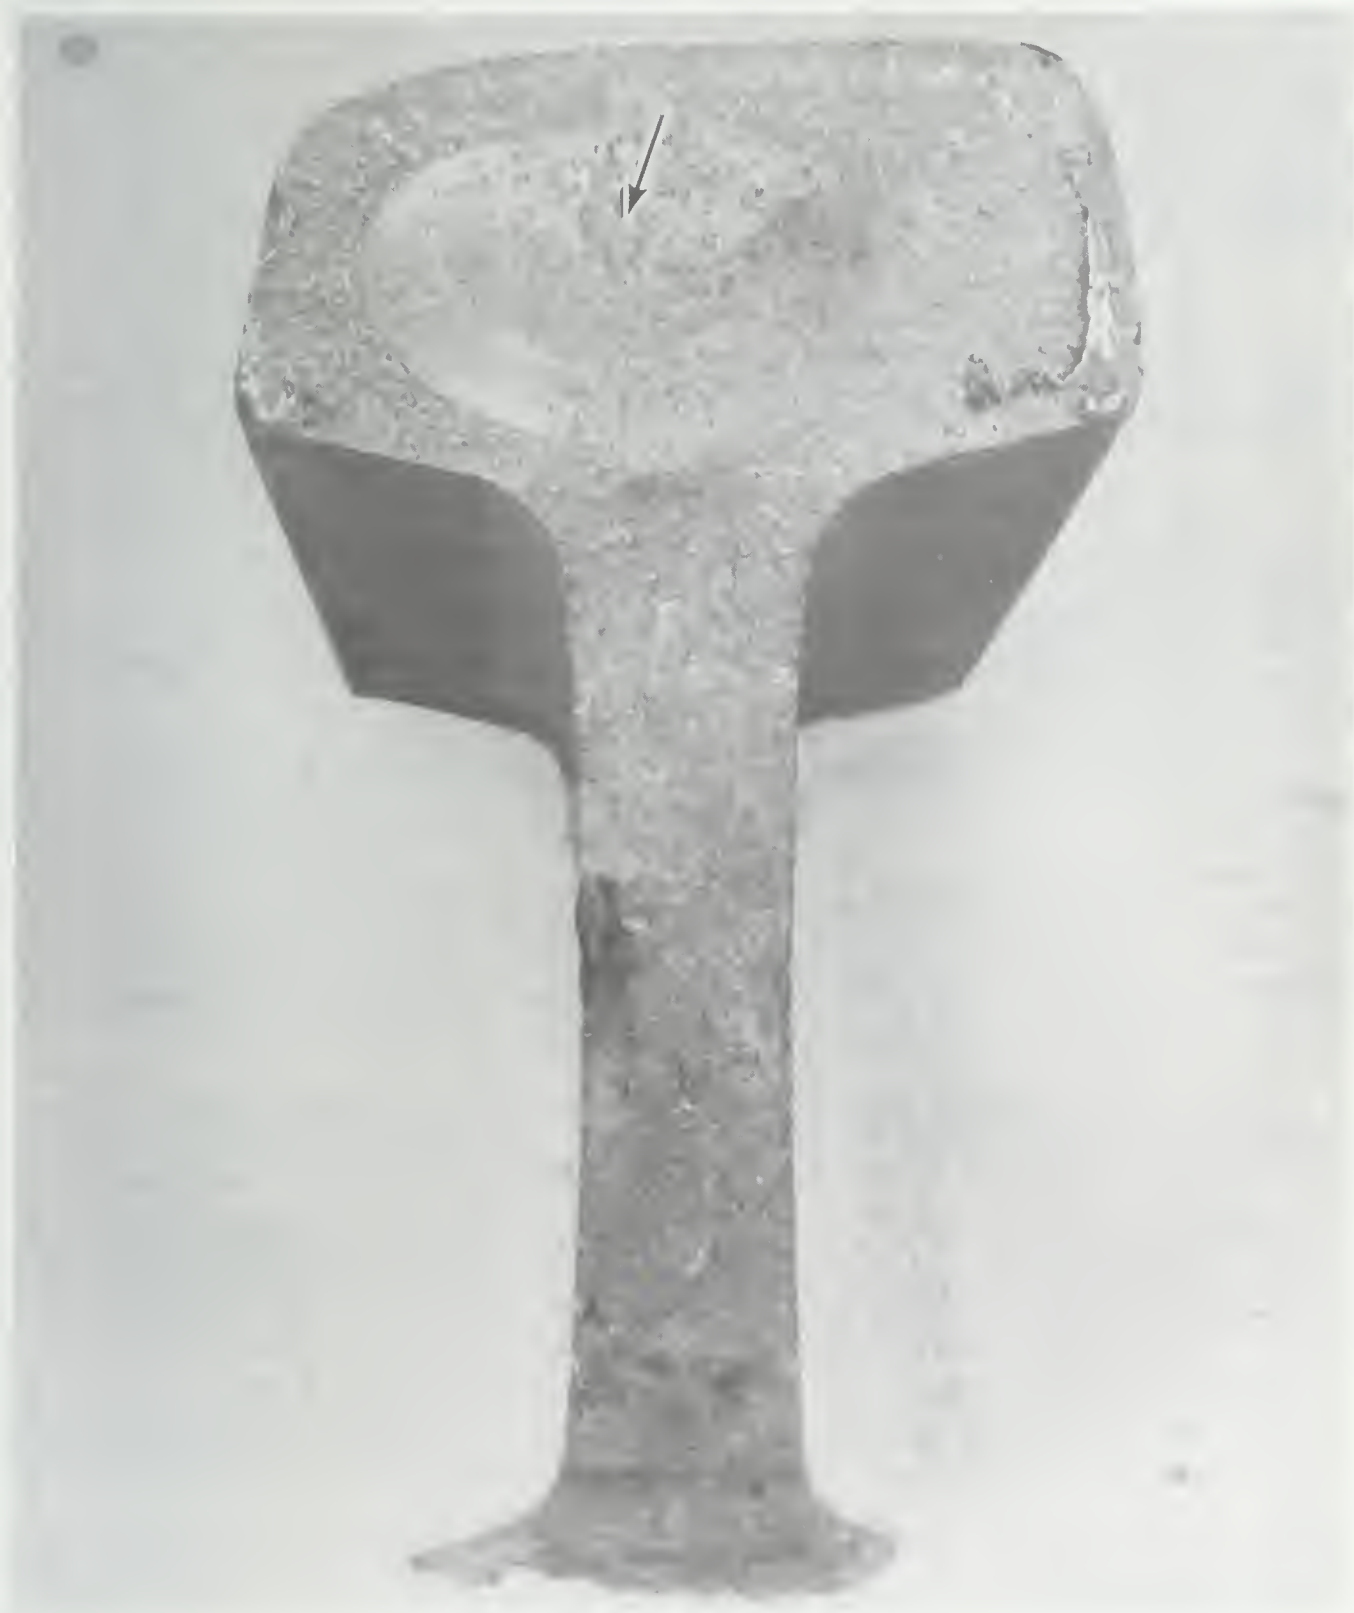
Figure 5. Cross-section of failed rail showing transverse fissure.
